**FIFTH FIVE-YEAR REVIEW REPORT FOR  
WASTE DISPOSAL ENGINEERING SUPERFUND SITE  
ANOKA COUNTY, MINNESOTA**

**U.S. Environmental Protection Agency  
Region 5  
CHICAGO, ILLINOIS**

4/24/2018

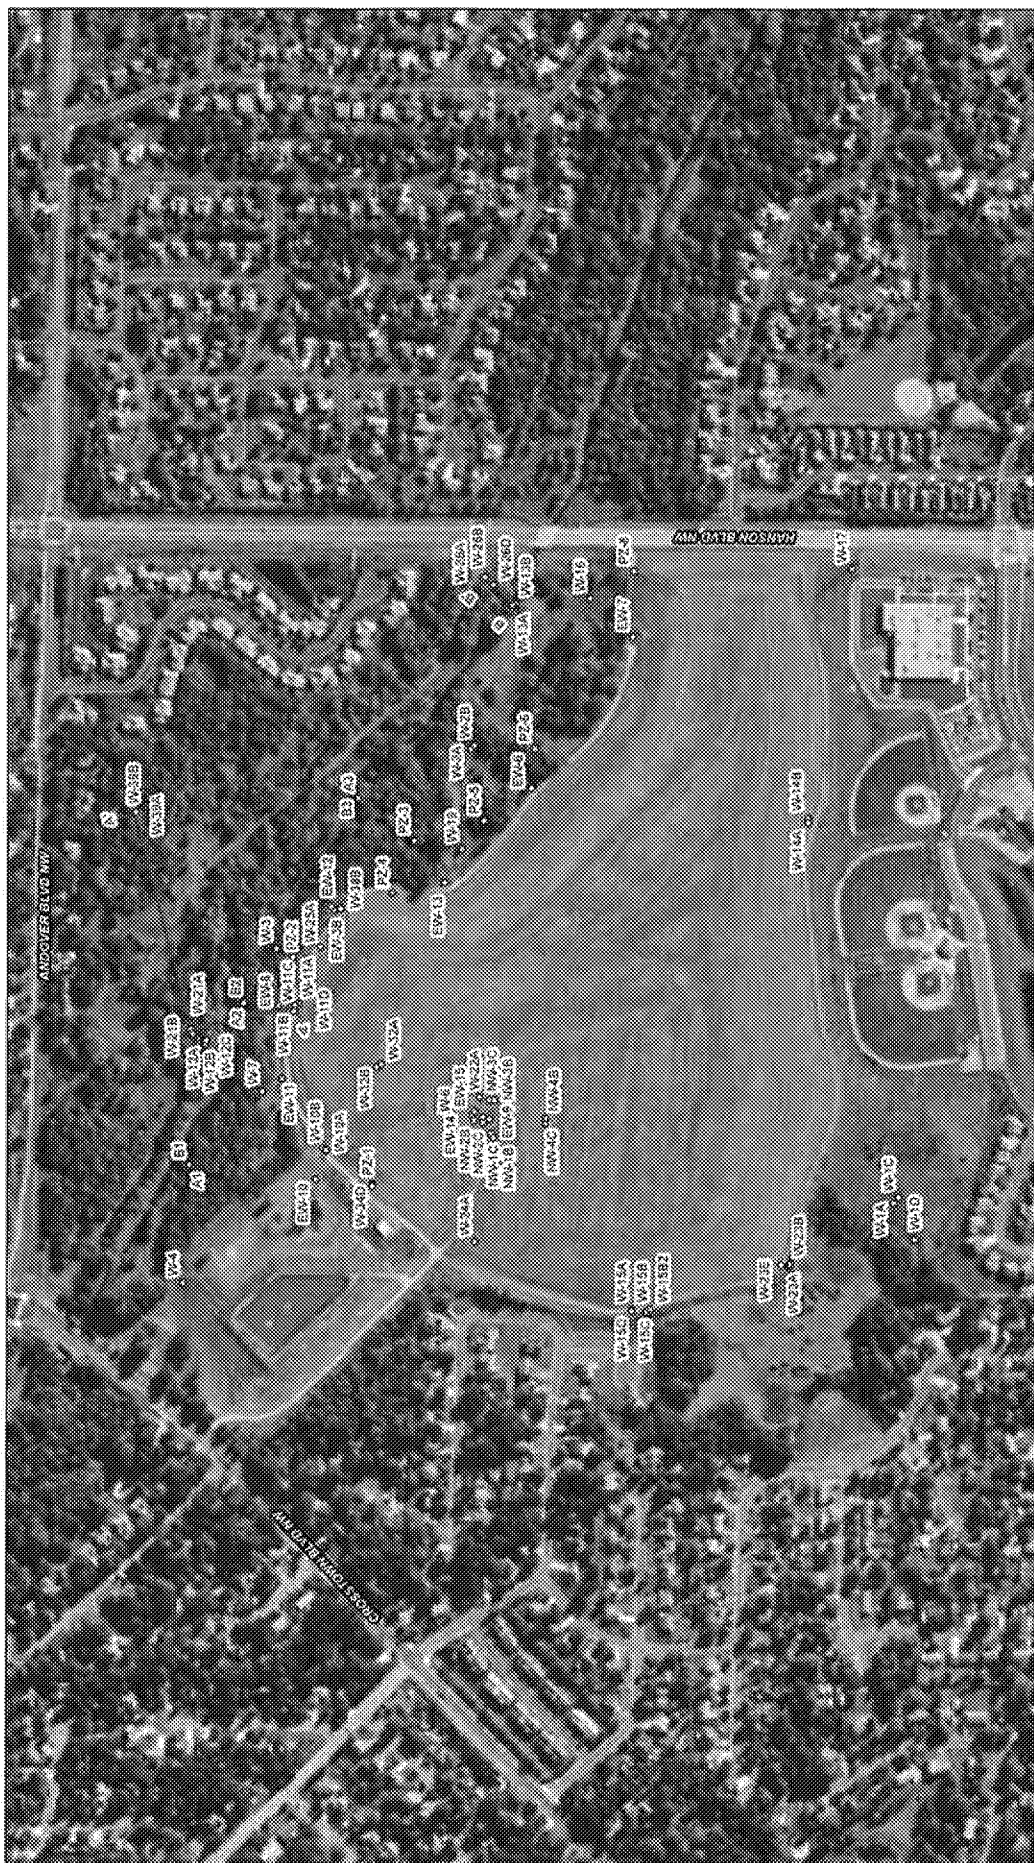
FIGURE 3

WASTE DISPOSAL ENGINEERING INC. CLOSED LANDFILL  
ANDOVER, MINNESOTA  
GROUNDWATER ASSESSMENT NORTH OF COON CREEK

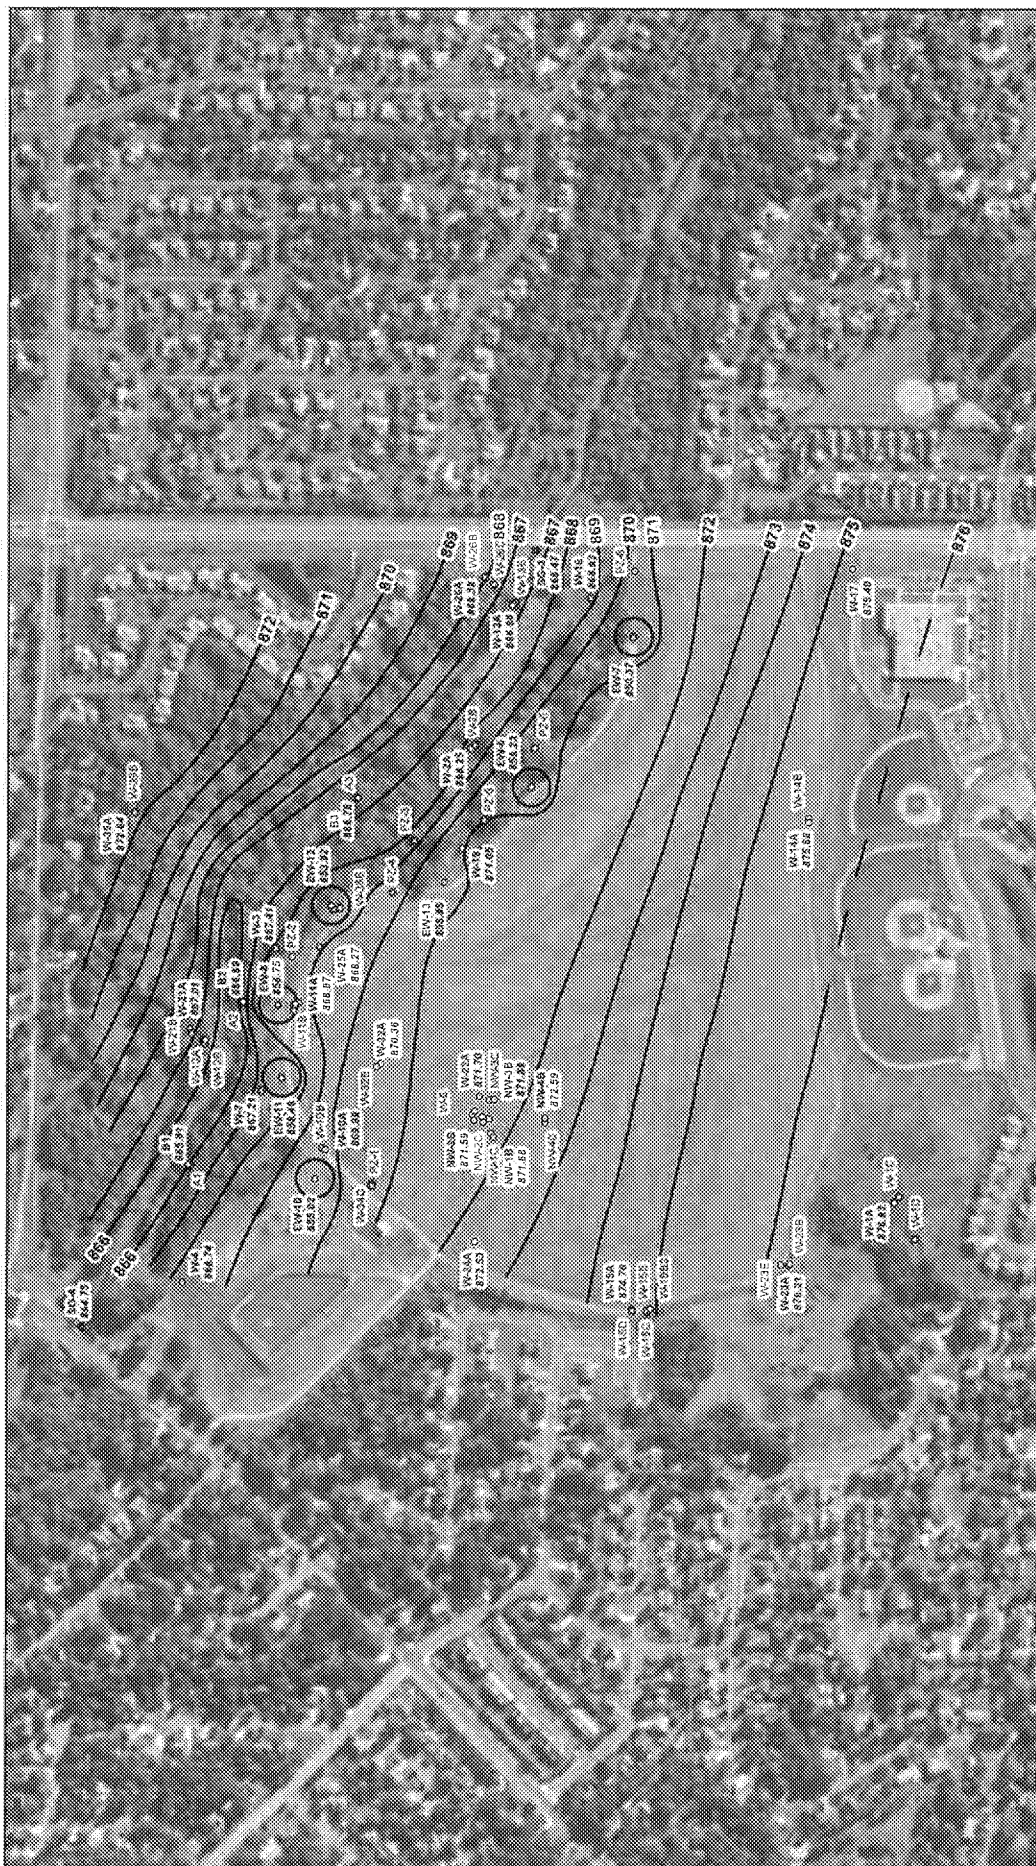
**FIGURE 4**

WASTE DISPOSAL ENGINEERING INC. CLOSED LANDFILL  
ANDOVER, MINNESOTA  
GROUNDWATER ASSESSMENT NORTH OF COON CREEK  
GROUNDWATER CONTOURS  
UPPER SAND AQUIFER - 4/18/16

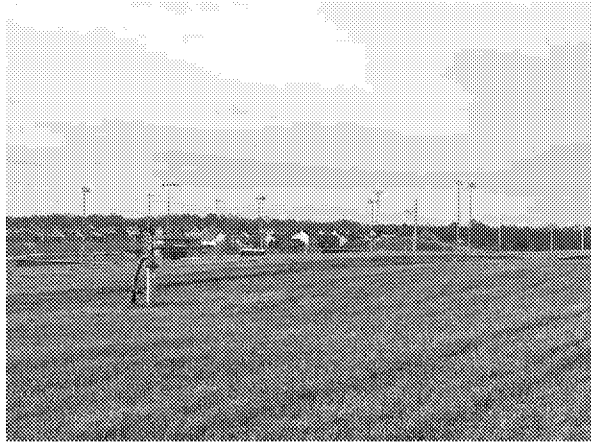
No ponds were observed on the landfill surface which would indicate significant settlement. The vegetated landfill cover showed evidence of having been mowed. No issues were observed with regard to the operation of the landfill or gas venting system or the groundwater monitoring system. At the time of the inspection, extraction wells were being redeveloped, which is a normal maintenance procedure for this Site. MPCA noted that an area of minor erosion by the creek is undercutting the landfill fence at one location, and that repair was in process.

Landfill surface with ball field in background

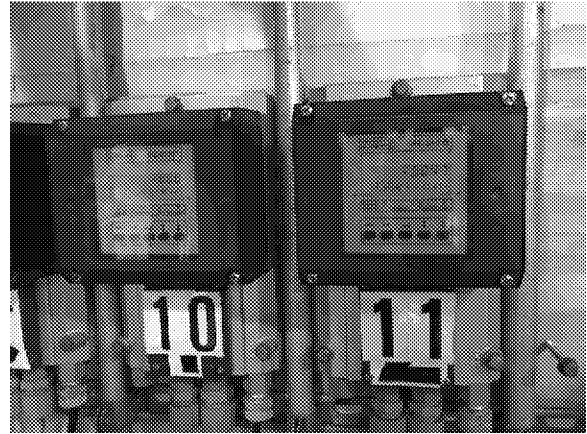
Extraction well flow meters

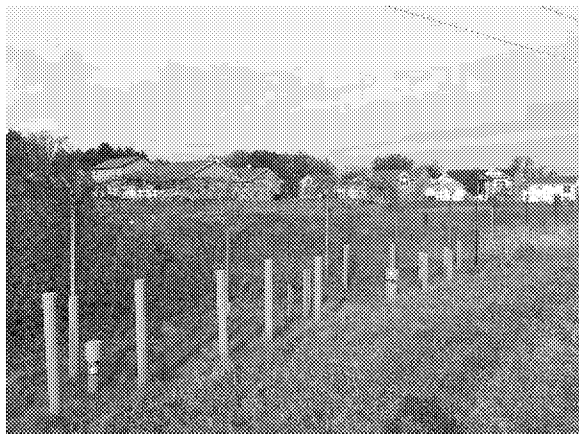
Groundwater monitoring wells located between landfill and residences

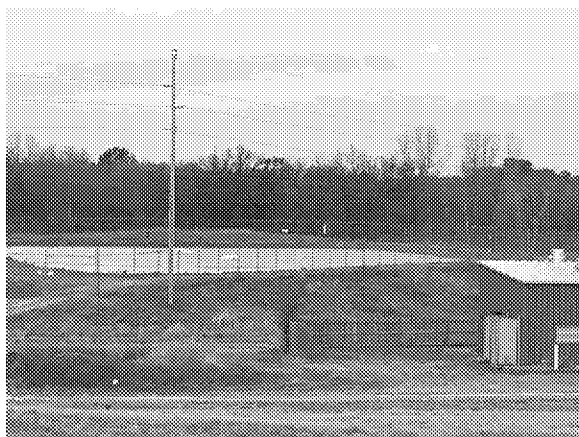
Fenced groundwater treatment pond

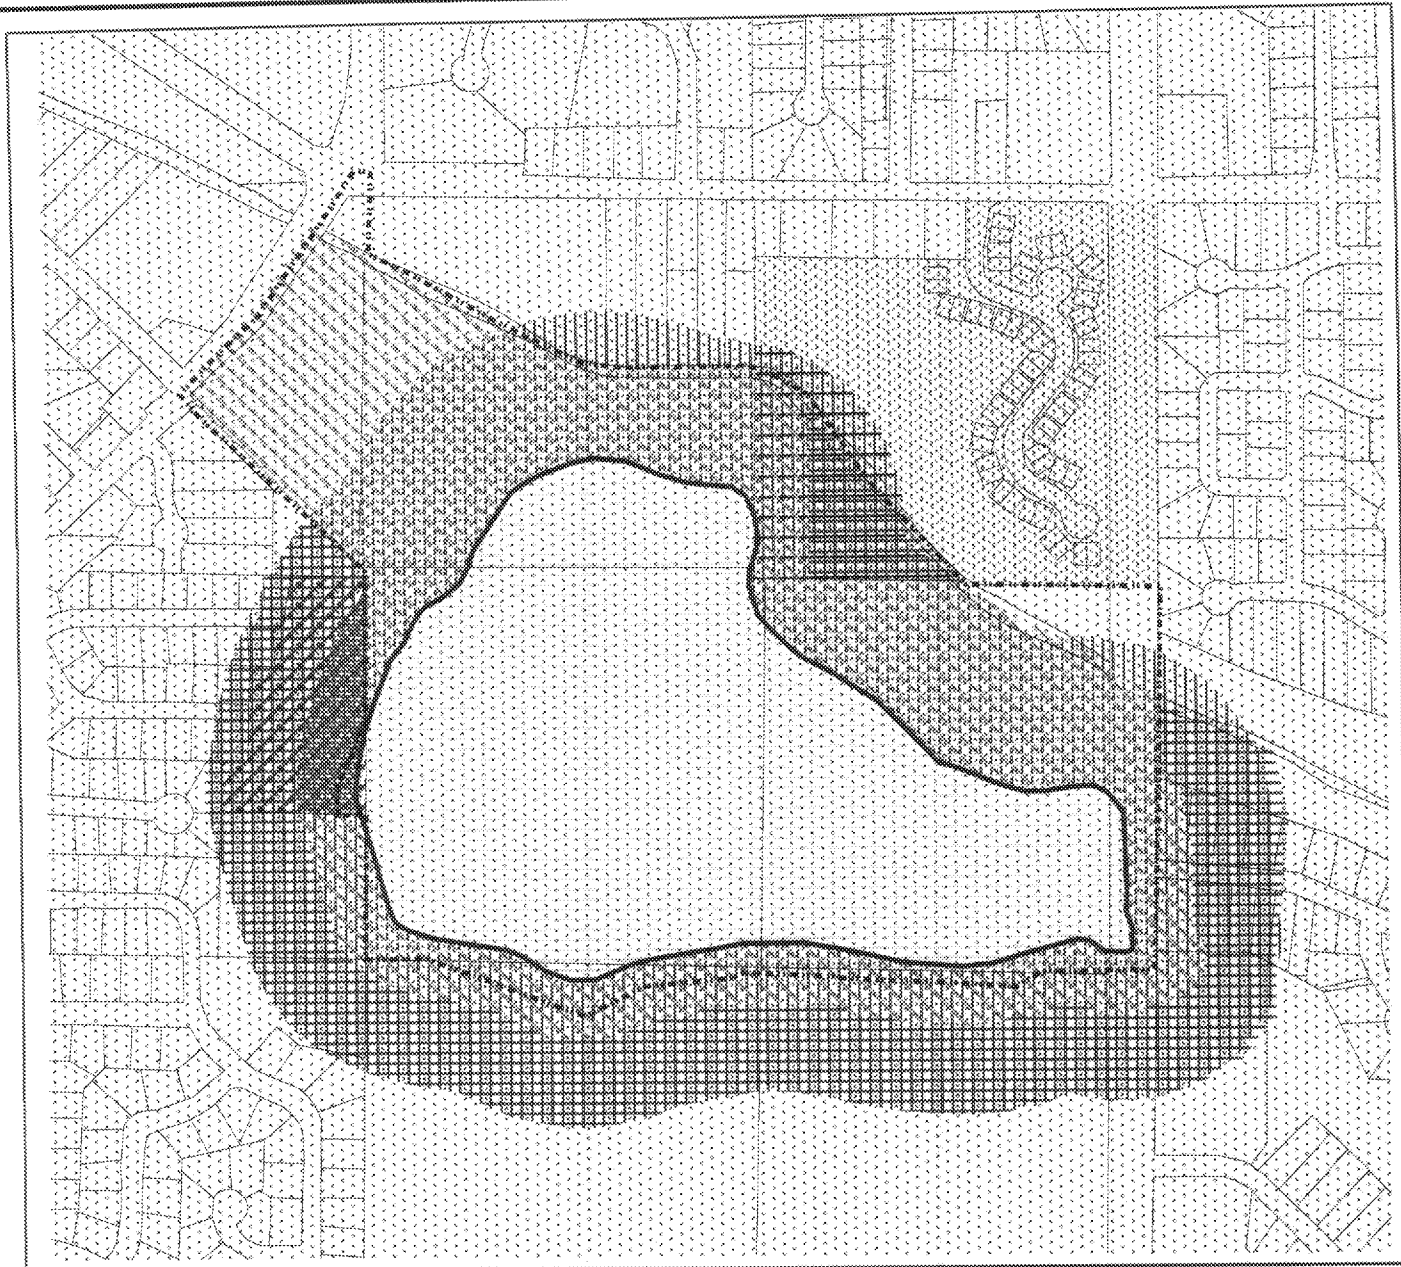
Figure 8b

## All Development Restrictions

- ==== 500' from refuse boundary: No groundwater extraction from Upper Sand Aquifer without prior MPCA approval.
- No groundwater extraction from Lower Sand Aquifer without prior MPCA approval
